## Half-Joint Risk Management Report - Brigsteer

Document no: BCU00015-JAC-SBR-6330-RP-SL240-CB-001

Risk Management and Structural Assessment of Post Tensioned and Half-Joint Bridges SL240 Brigsteer and SL221 Underbarrow  
17 July 2024

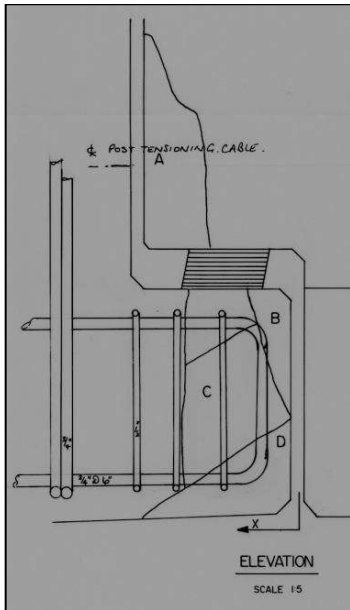
Figure 3 – Brigsteer West Half-Joint Sketch

The historical drawings for the cantilevers do not show the size of each bar mark and call off spacings of bar marks sporadically. There are no accompanying bar bending schedules to indicate sizes, shapes and numbers of bars for each bar mark.

Showing size of local reinforcement

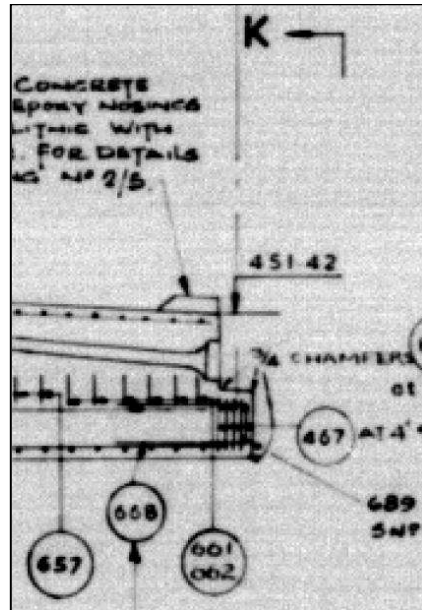
Figure 4 – Brigsteer West Half-Joint

Showing reinforcement layout of lower nib.

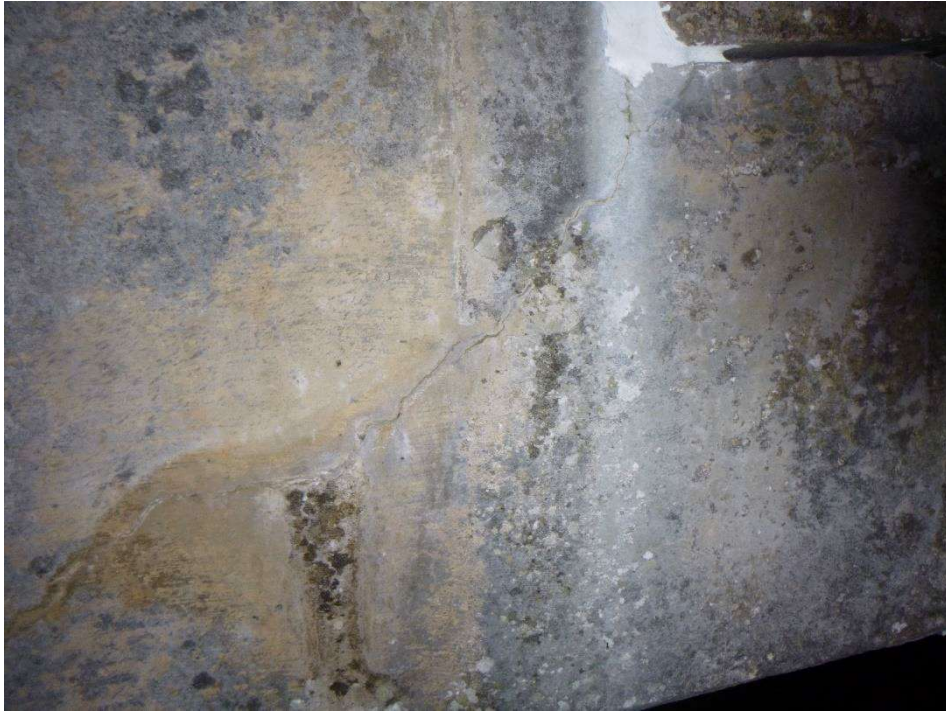
Defect Description	Reference	Defect Identification	Zone (see Figure 8)	Damage Rating	Defects in Combination
0.2mm Shear crack to lower nib re-entrant corner	Appendix B, Photograph 1	North east half-joint	3	Slight	Leachate
0.15mm Shear crack to lower nib re-entrant corner	Appendix B, Photograph 2	South east half-joint	3	Slight	Leachate
Shear crack to lower nib re-entrant corner	Appendix B, Photograph 3	North west half-joint	3	Very slight	Leachate
Shear crack to lower nib re-entrant corner	Appendix B, Photograph 4	South west half-joint	3	Very slight	Leachate
Exposed vertical rebar	Appendix B, Photograph 4	South west half-joint	3	Very slight	-

Photograph 1 - Crack on north face

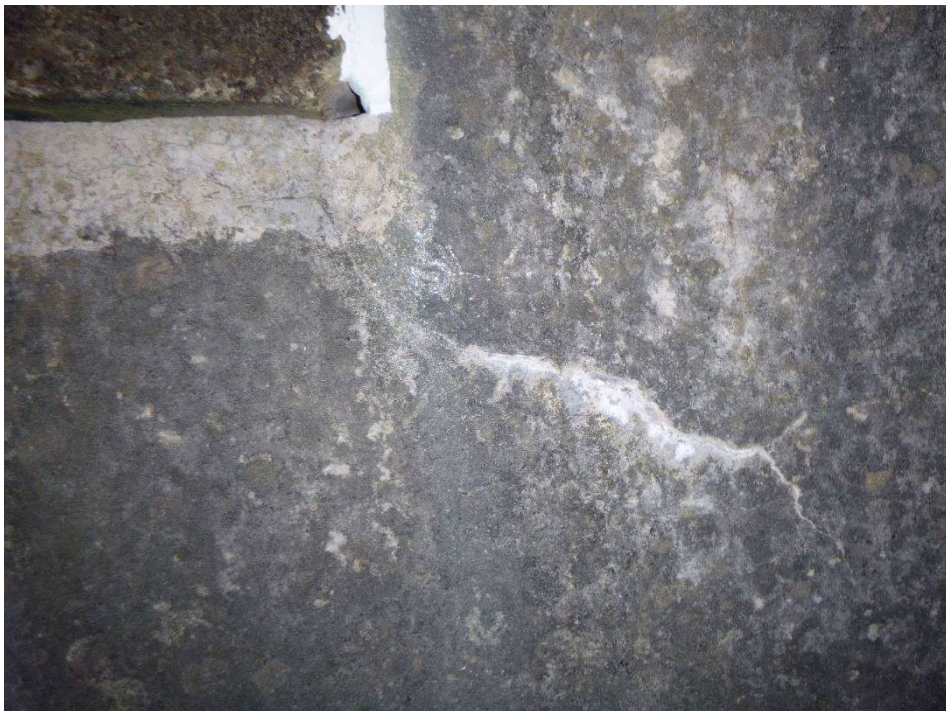
Photograph 2 - East joint south face crack

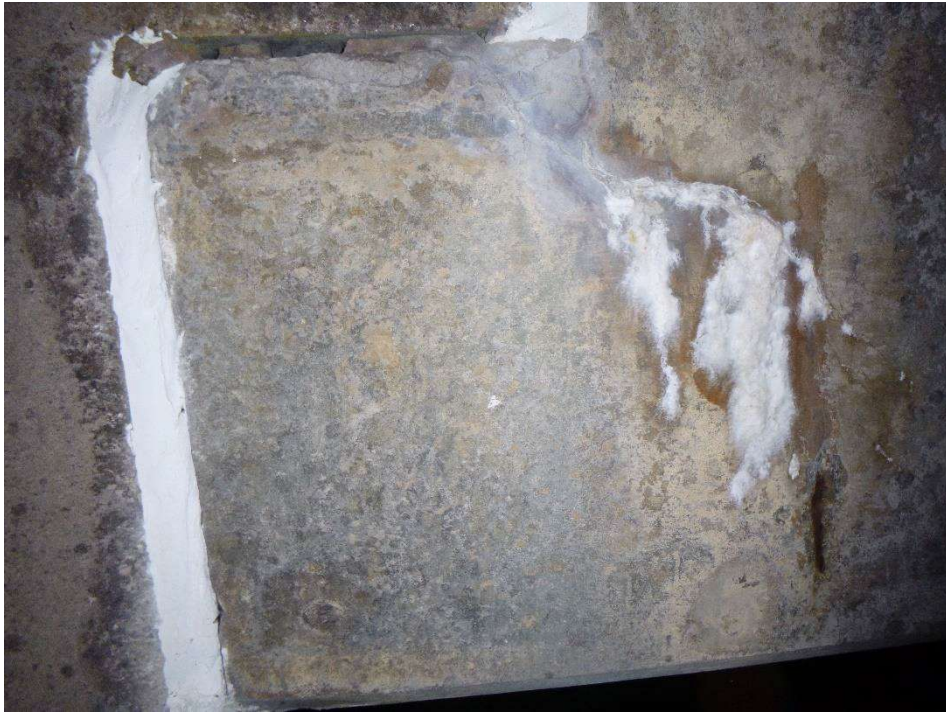
Photograph 3 - West joint north face crack

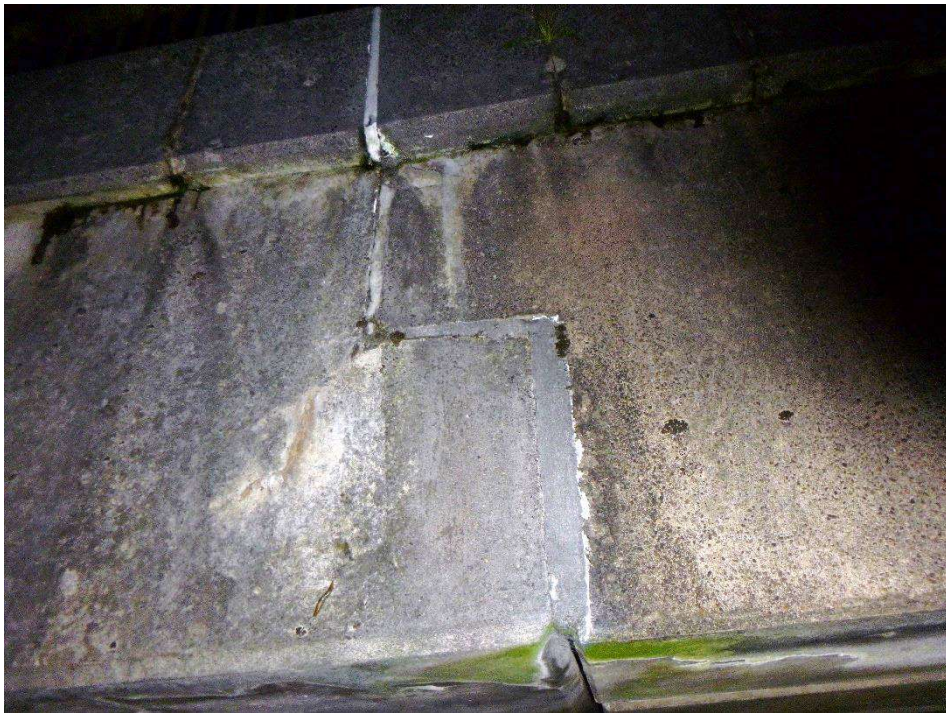
Photograph 4 - West joint south side elevation. Note, hairline crack.
