## Half-Joint Risk Management Report - Brigsteer

Document no: BCU00015-JAC-SBR-6330-RP-SL240-CB-001

Risk Management and Structural Assessment of Post Tensioned and Half-Joint Bridges SL240 Brigsteer and SL221 Underbarrow  
17 July 2024

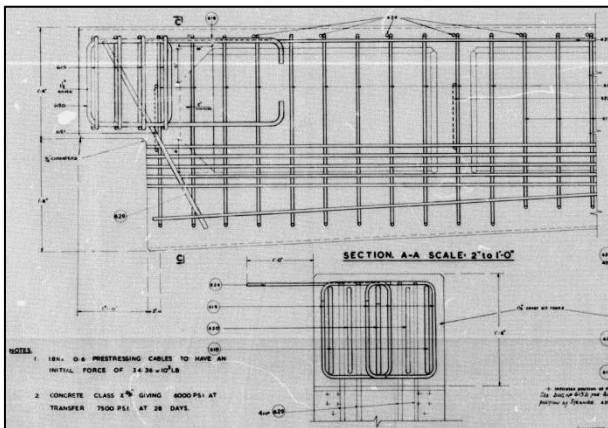
Figure 5 – Suspended Span Details (external beam)

Historical drawings show the details for the suspended span to be similar for both structures (detailed on the same drawings). The inner precast concrete beams are inverted T-beams longitudinally pre-tensioned and transversely post-tensioned together. Links protrude from the tops of the inner beams to act compositely with the in-situ deck slab. The outer precast concrete beams are pre-tensioned box beams. They are slightly deeper than the inner beams and bars protrude from inner side of each edge beam at its upper corner to tie into the adjacent in-situ deck slab.

The historical drawings do not show the size of each bar mark and call off spacing of bar marks sporadically. There are no accompanying bar bending schedules to indicate sizes, shapes and numbers of bars for each bar mark.
